1. REPORT DATE (DD-MM-YYYY) 04-06-2003		2. REPORT TYPE Technical Presentation		3. DATES COVERED (From - To)	
4. TITLE AND SUBTITLE Usage of Fiber Grating Strain Sensors for Diagnostics of Composite Pressure Vessels				5a. CONTRACT NUMBER F04611-02-C-0007	
				5b. GRANT NUMBER	
				5c. PROGRAM ELEMENT NUMBER

**USAGE OF FIBER GRATING STRAIN SENSORS
FOR DIAGNOSTICS OF COMPOSITE PRESSURE VESSELS**

16th International Conference on Optical Fiber
Sensors (OFS-16)
October 13-17, 2003
Nara, Japan

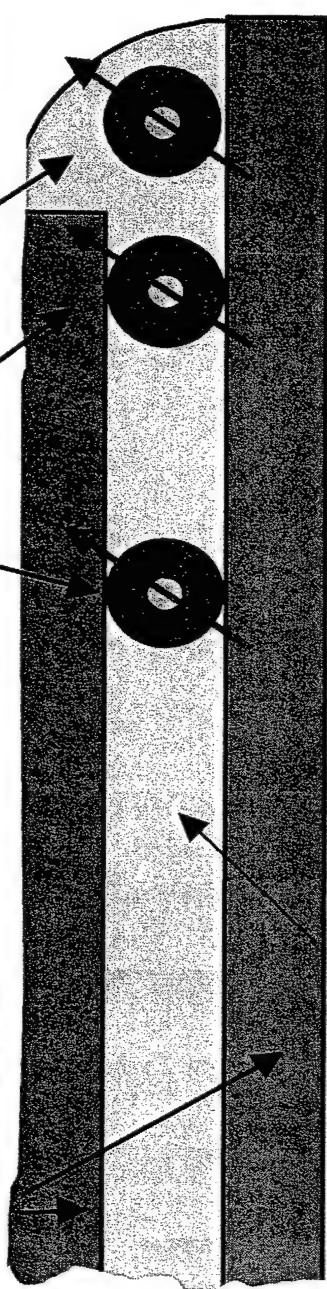
Sensors embedded in, and Retro-fitted to, an Adhesive Joint

Bonded materials Embedded fiber grating strain sensor positions tested

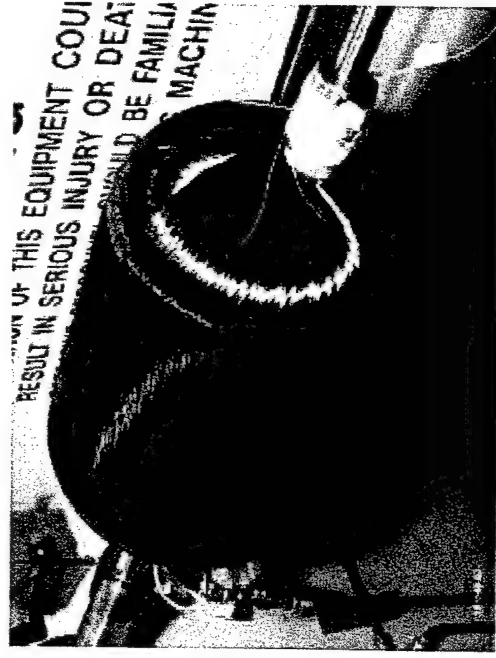
Casing with Embedded Fiber Grating Strain Sensors

Parameter	Characteristics
Composite	T700/UF3369
Liner	Approx. 12" dia. & 20" length Cross linked Polyethylene 5.7 lbs. Made by Roto Molding of Utah
Winding Plan: Wind directly over plastic liner	3 Helical layers (0.0705 in. thick) 2 to boss -10 deg. X 1stepped back one bandwidth -16 deg. Xsb 7 hoop plies (0.0823 in. thick) 4 tows/band 5 lbs/tow tension
Winding Sequence	X O O O Xsb O O O X O
